Yes, Virginia, there is a converter station after all

Thanks to a massive team effort by RMR crews, the Virginia Smith Converter Station is now fully functional after a fire damaged a transformer last Memorial Day.

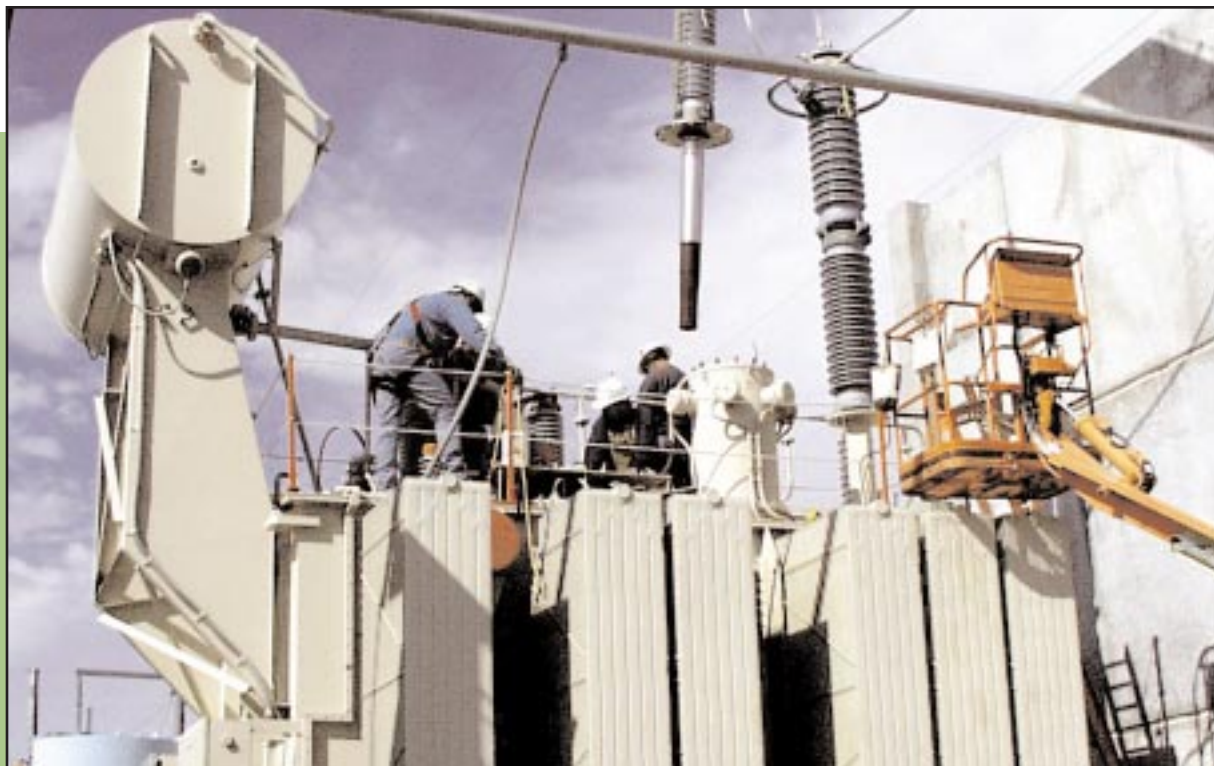
The Brush, Colo., crew prepares to install a new transformer bushing at the Virginia Smith Converter Station.

The fire started when a transformer bushing exploded. (A bushing insulates an energized conductor as it enters a piece of electrical equipment.) Oil leaking around the bushing fueled the fire until the local fire department could extinguish it.

In October, crews from Loveland and Cheyenne joined the Brush team in replacing the bushings—a massive undertaking. Replacements involved draining 9,000 gallons of oil from each trans-

former, removing and installing the bushings, refilling the tanks with oil and venting and testing, among other tasks.
